INSPECTION OF: Site Scaffoldings

SITE: Aberavon House, Port Talbot, SA13 1 PB

UNIQUE IDENTIFICATION NUMBER: AS 260 South Elevation

Date of Scaffold Inspection: Tuesday 27th March 2018

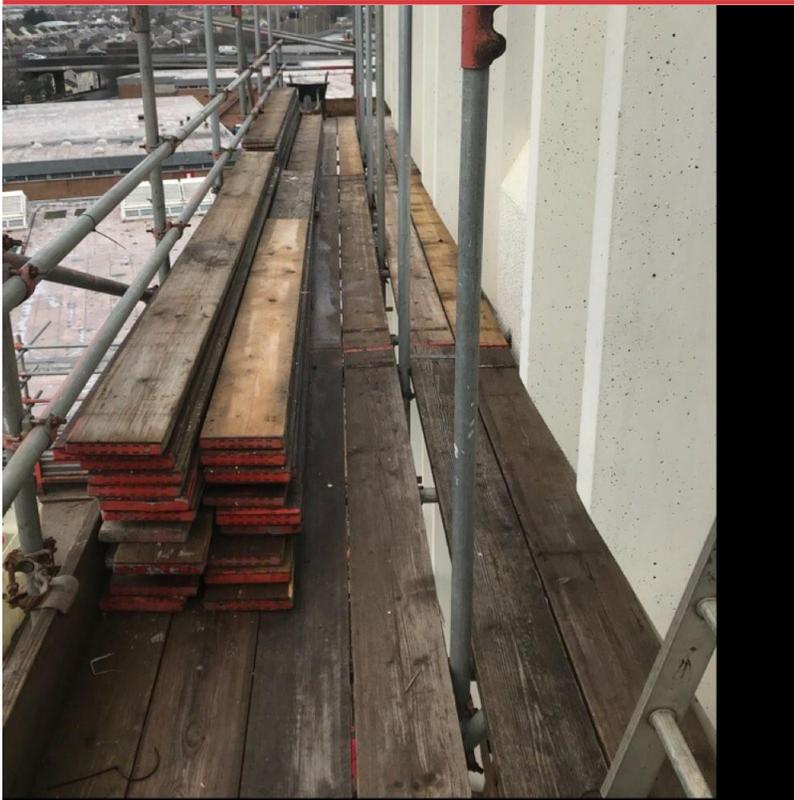
SOUTH ELEVATION ACCESS TOWER

There are scaffolds materials on the South Elevation Access Tower that need to be removed in order to create greater access

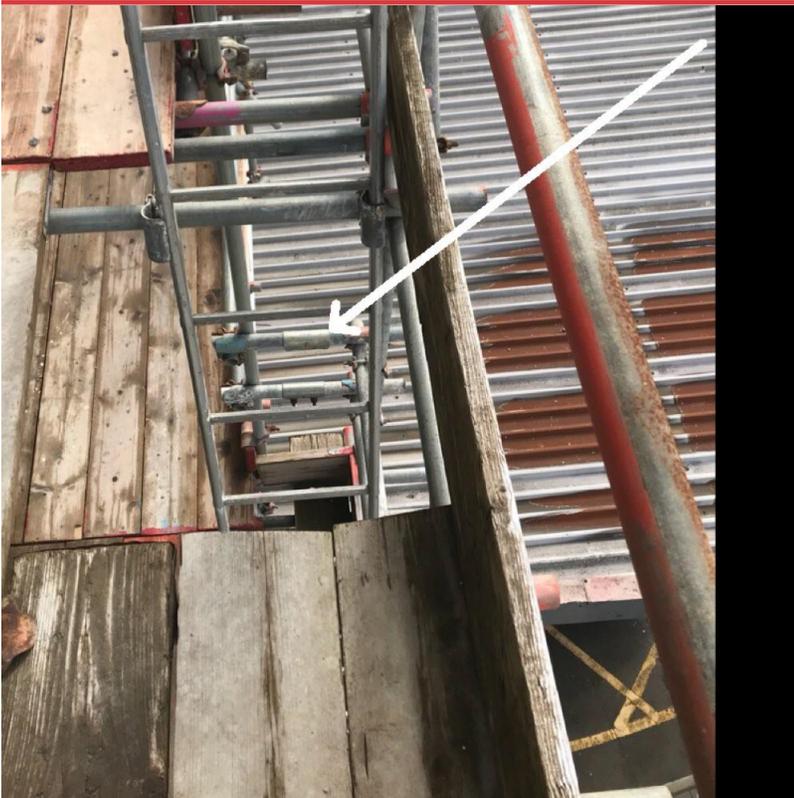
SOUTH ELEVATION ACCESS TOWER

The Access ladder had not been secured but single fittings have been used as opposed to rope lashing as per TG20:13

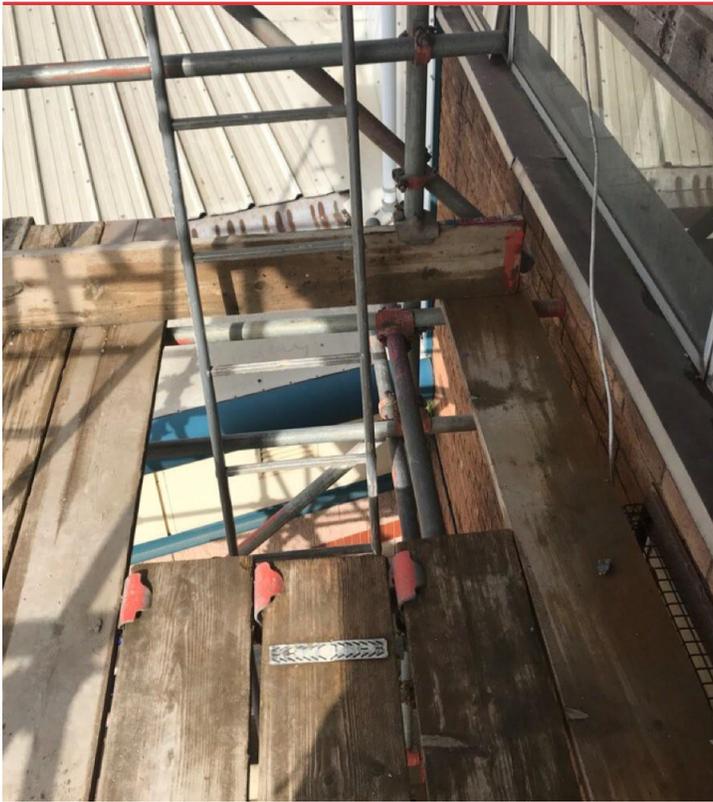
SOUTH ELEVATION ACCESS TOWER

There are Trap Doors missing from the Working Lifts that need to be in position in order to prevent falls from height

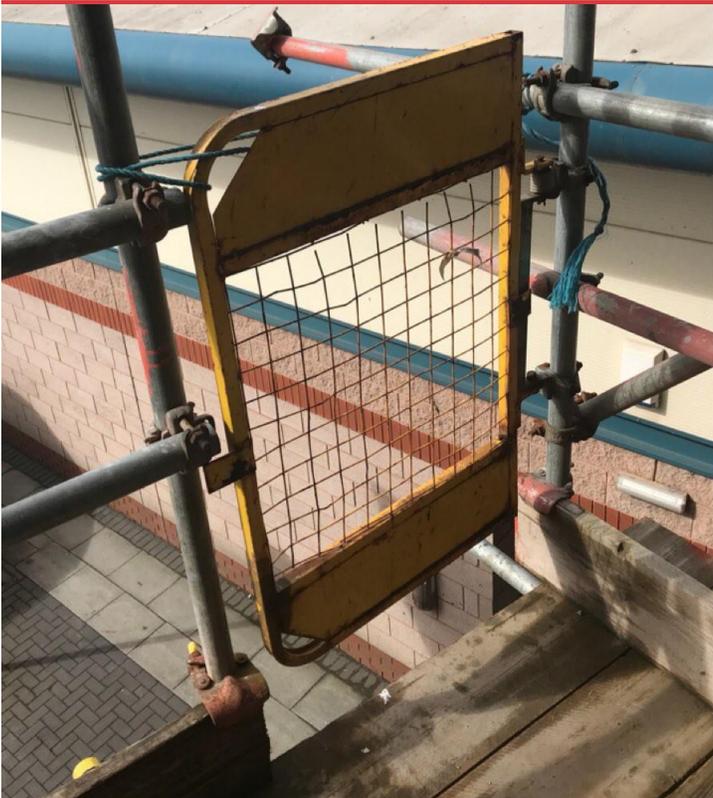
SOUTH ELEVATION ACCESS TOWER

The Access ladder had been removed from the scaffold, the gate has been tied off in order to prevent falls from height.

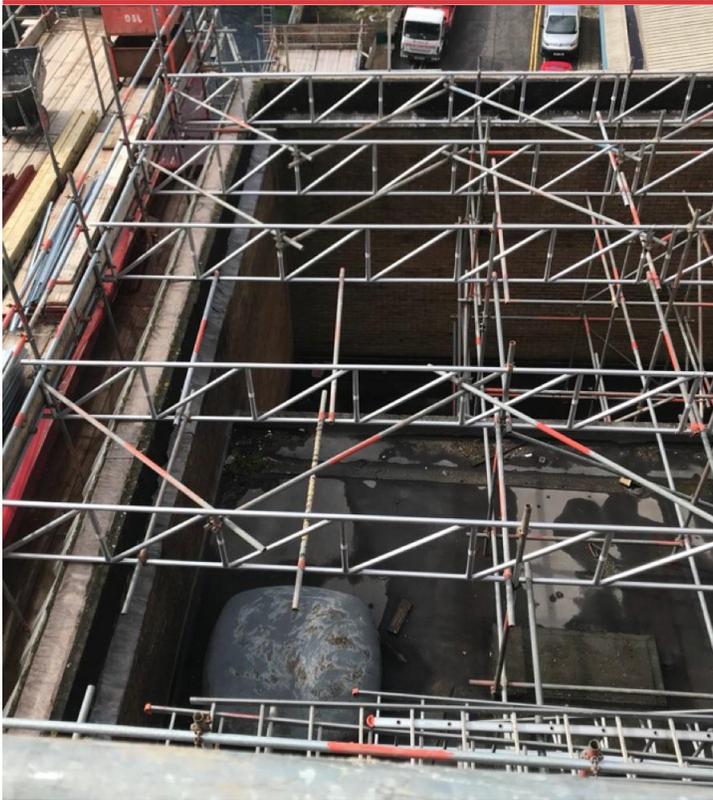
SOUTH ELEVATION

There are sufficient beams and ties on the scaffold on the South Elevation in order to meet the requirements of the Design and TG20:13

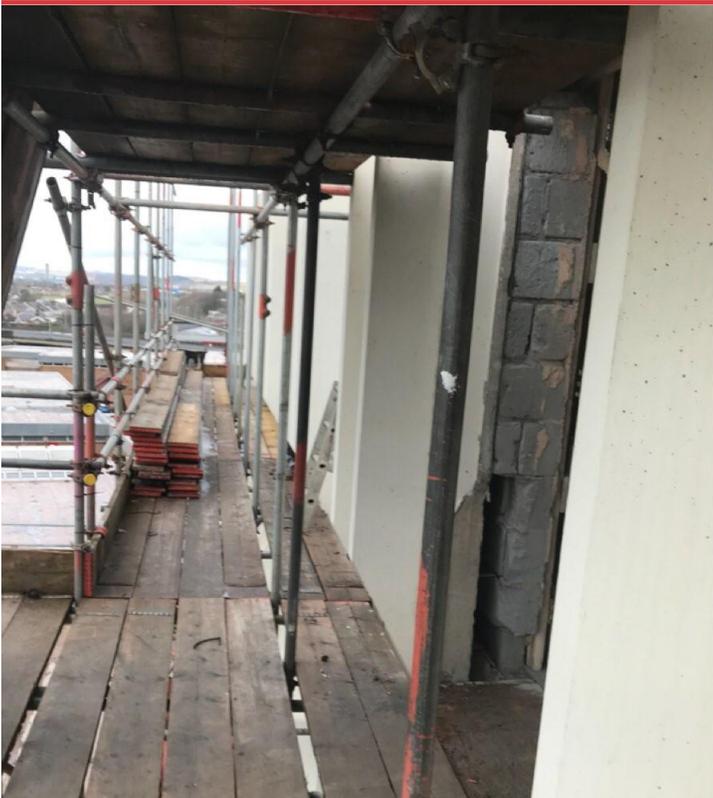
SOUTH ELEVATION WORKING LIFTS

Ties had been removed from the highest Working Lift from when the Top Working Lift was dismantled

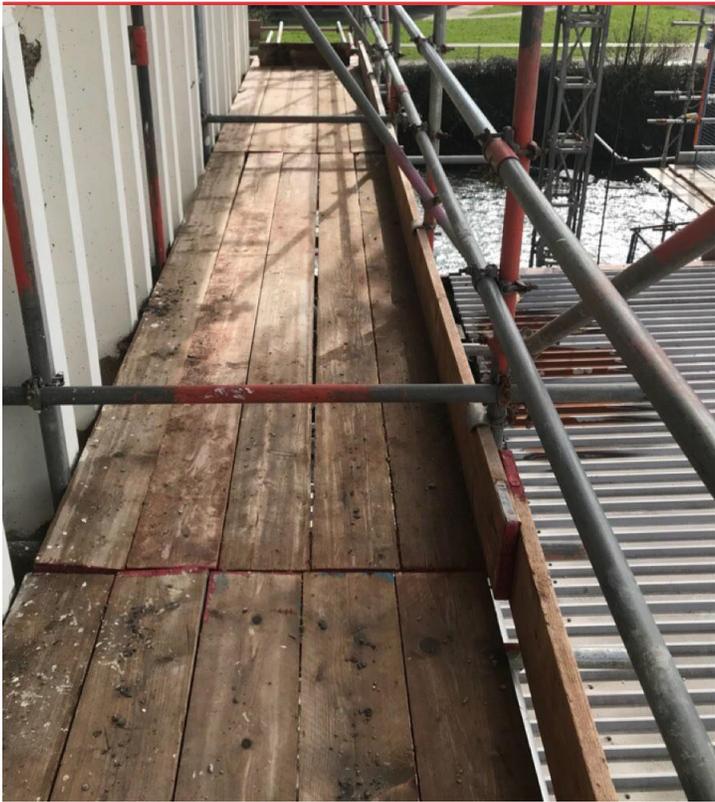
SOUTH ELEVATION

The Working Lifts were clear of waste and debris and the Housekeeping was of optimum condition but the scaffold materials need to be removed prior to next use

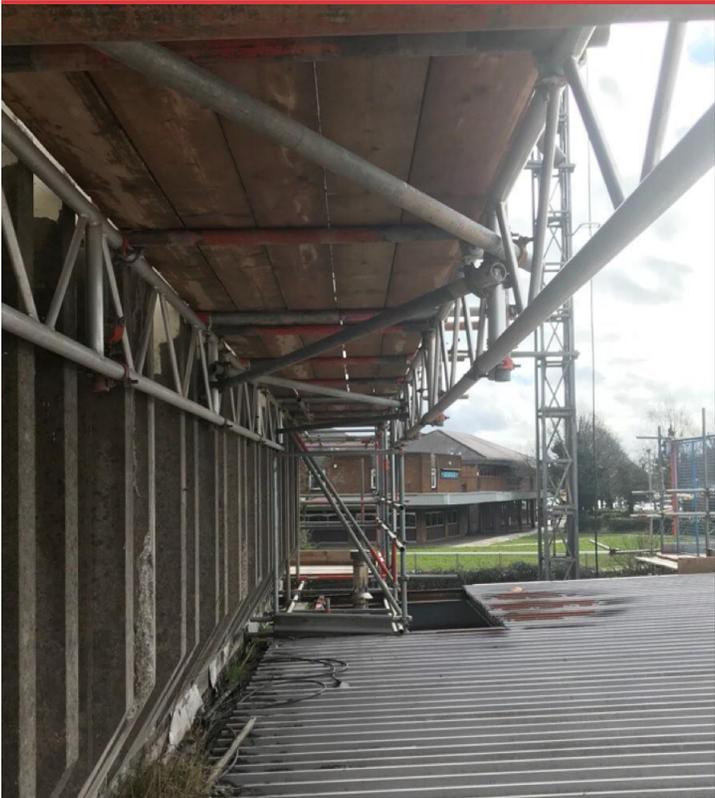
SOUTH ELEVATION ACCESS TOWER

There are sufficient beams being used on the scaffold on the South Elevation

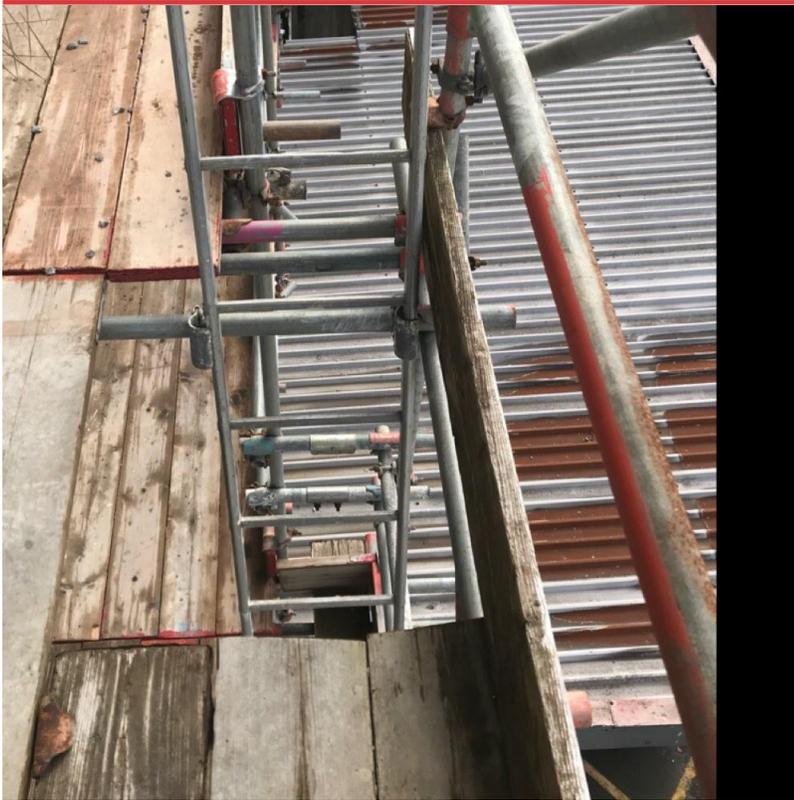
SOUTH ELEVATION

There is a Trap Door missing on the Working Lift that needs to be replaced in order for prevent falls from height and objects falling from height

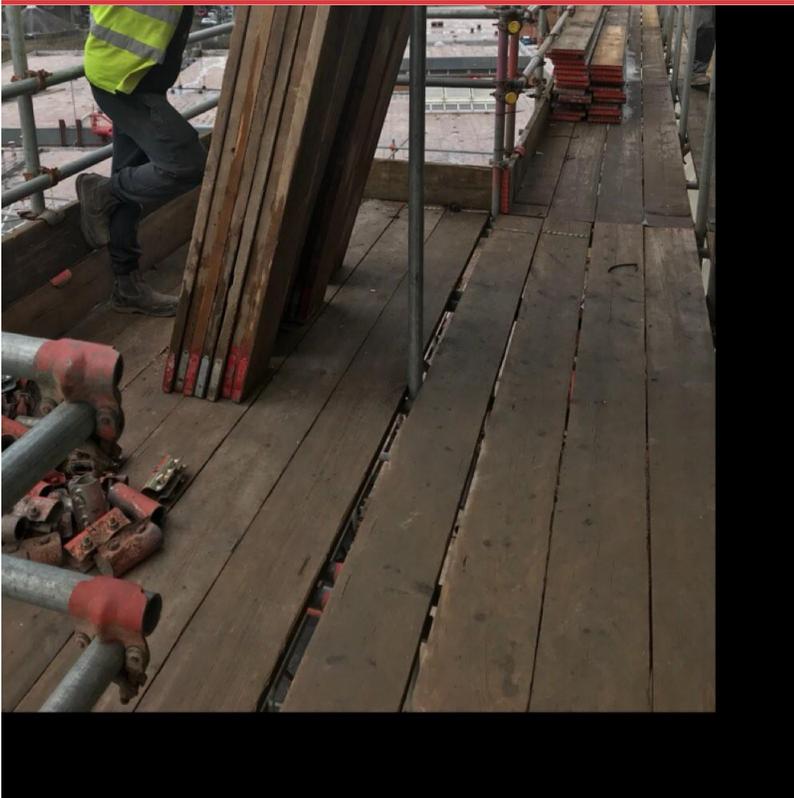
SOUTH ELEVATION

The scaffold materials placed on the South Elevation need to be removed prior to next use

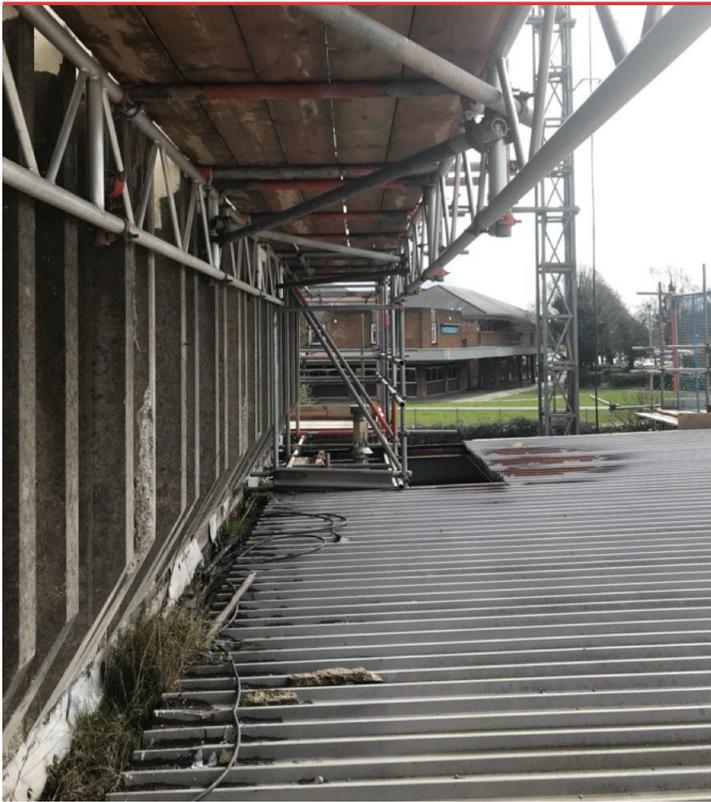
SOUTH ELEVATION

As per Design sufficient ties and beams have been used in order to meet the compliance of the Design and TG20:13

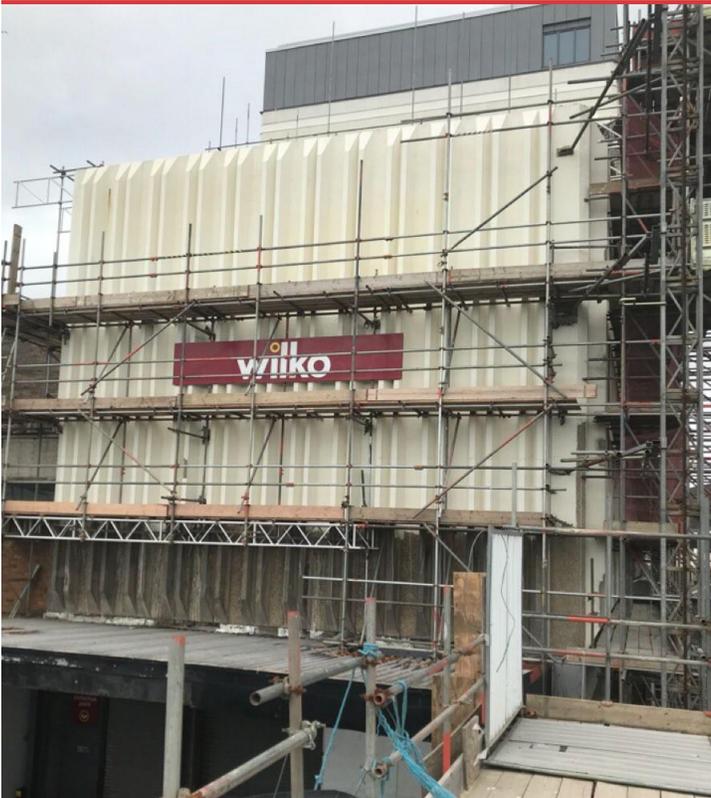
SOUTH ELEVATION

There are sufficient ties and bracing in the scaffold in order to meet the compliance of the Design and TG20:13

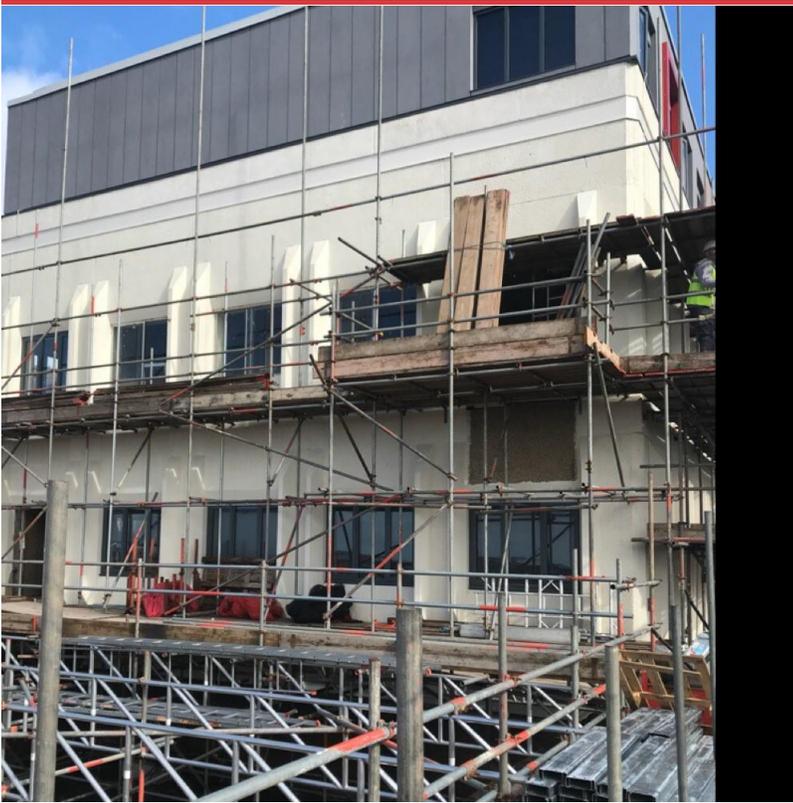
SOUTH ELEVATION

Scaffold materials need to be removed from Working Lifts in order to create greater access, as illustrated, Working Lifts have been removed from the scaffold in order to meet the ongoing requirements of the project.

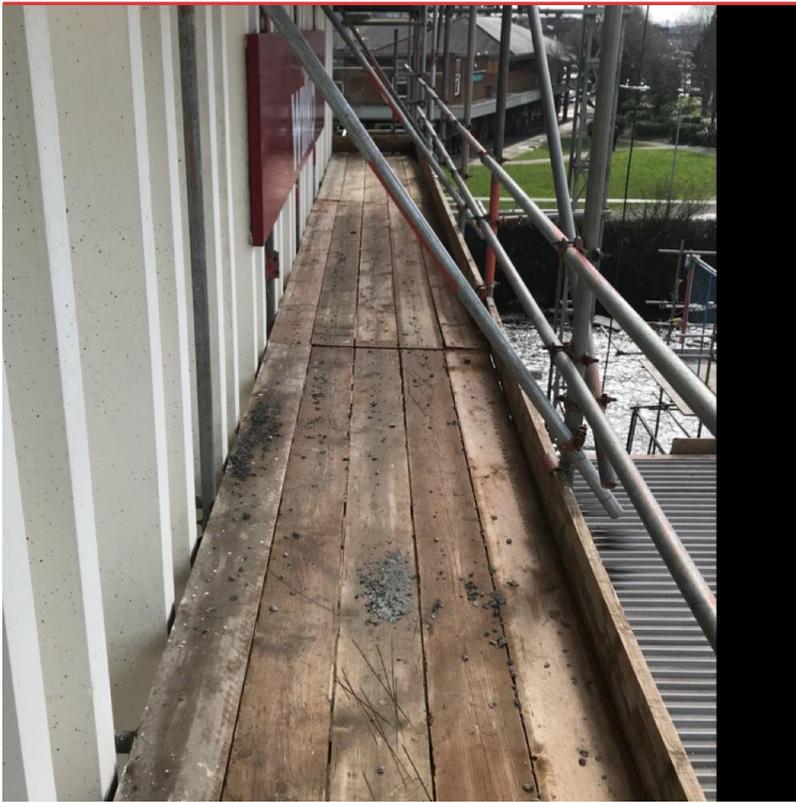
SOUTH ELEVATION

The Working Lifts were free from debris and waste materials on the Elevation nearest to the Rubbish Chutes
