# Cymru Scaffold Inspections

INSPECTION OF: Site Scaffoldings

SITE: Aberavon House, Port Talbot, SA13 1 PB

UNIQUE IDENTIFICATION NUMBER: AS 260 Rear Elevation

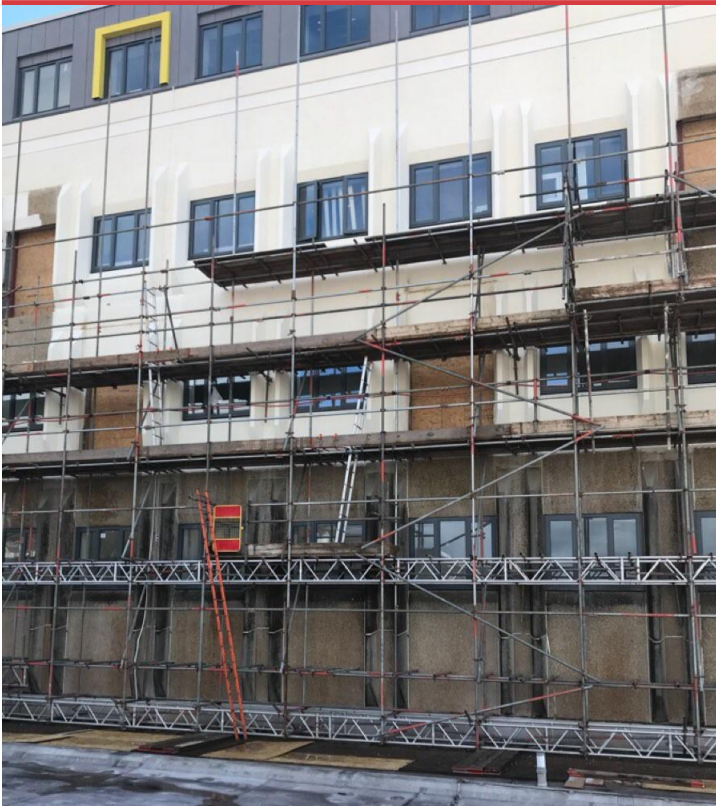
## REAR ELEVATION

The scaffolding on the Rear Elevation has sufficient ties in order to meet the requirements of the Design and TG20:13 but is not to be used until all of the modifications and alterations have been completed by the Scaffold Contractor

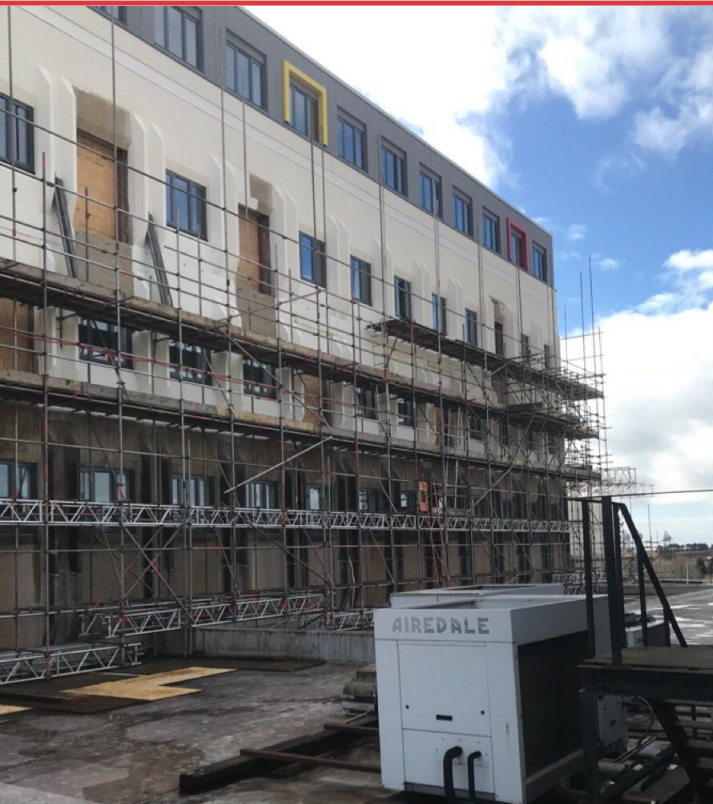
## REAR ELEVATION

The scaffolding on the Rear Elevation is not to be used until all the modifications and alterations have been performed by the Scaffold Contractor

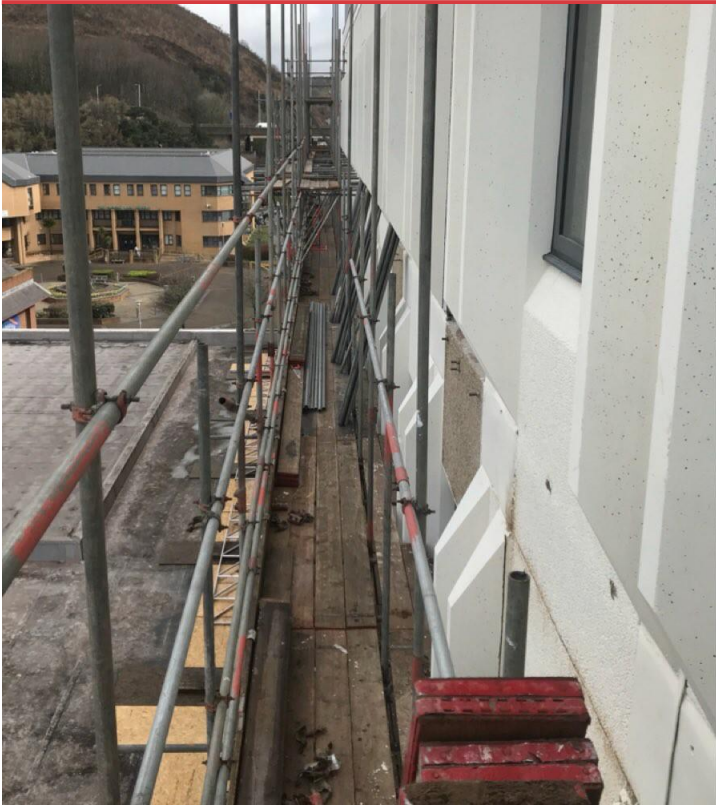
## REAR ELEVATION

The scaffold on the Rear Elevation has sufficient ties in order to meet the requirements of the Design and TG20:13

Alterations and modifications were being performed on the scaffold on the Rear Elevation during the scaffold inspection

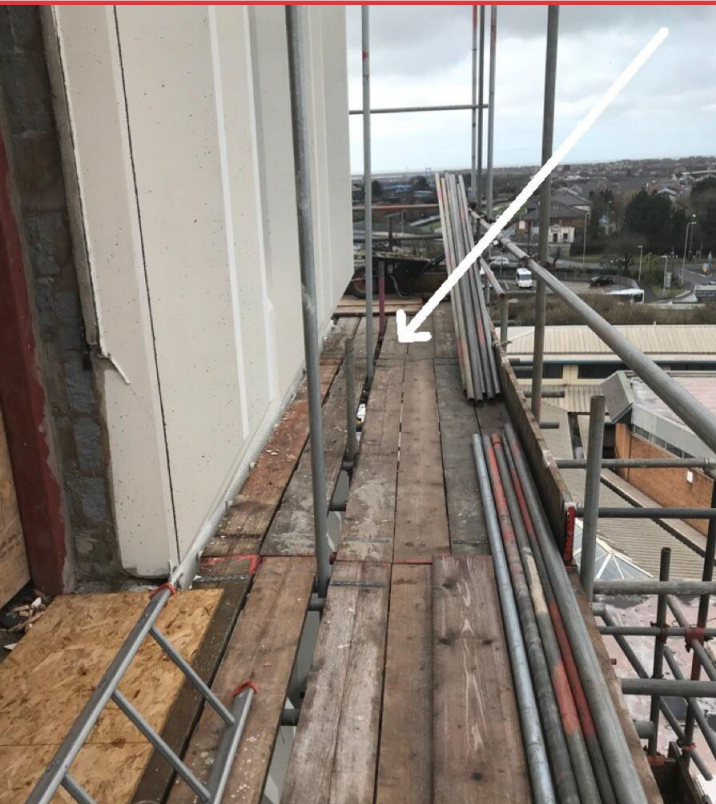
## REAR ELEVATION

The Working Lifts on the Rear Elevation are free of debris and waste, the protruding tubes were cut at such height in order to meet the requirements of the Contractors who were fitting the external Pods.

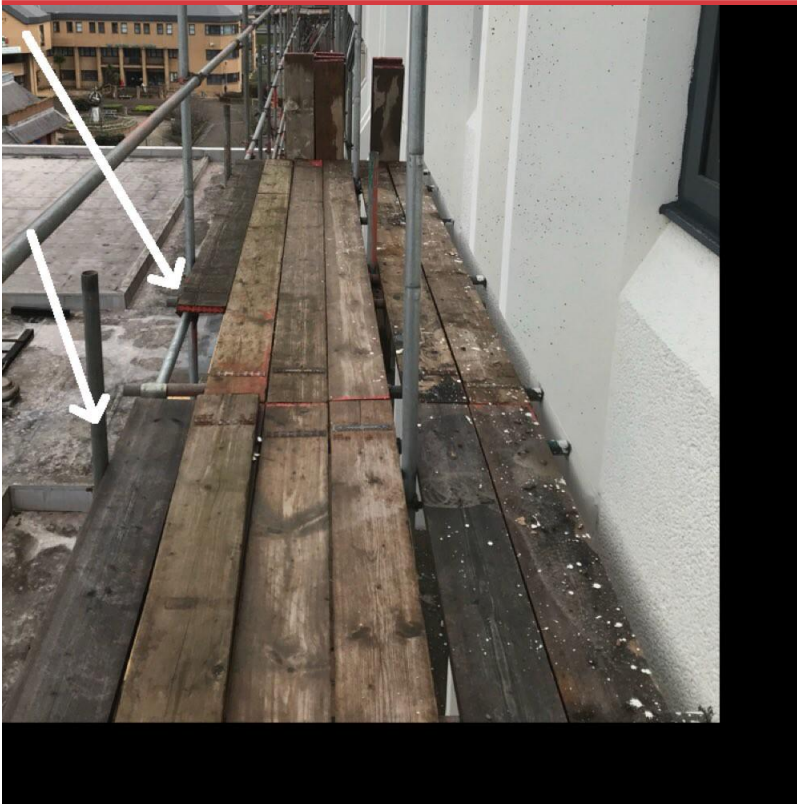
## REAR ELEVATION

The scaffolding on the Rear Elevation is not to be used until all of the scaffolding materials have been removed and all modifications and alterations have been completed.

There are scaffolding materials that need to be removed and Handrails put in place in order to create Double Handrails to prevent falls from height and meet the requirements of TG20:13.

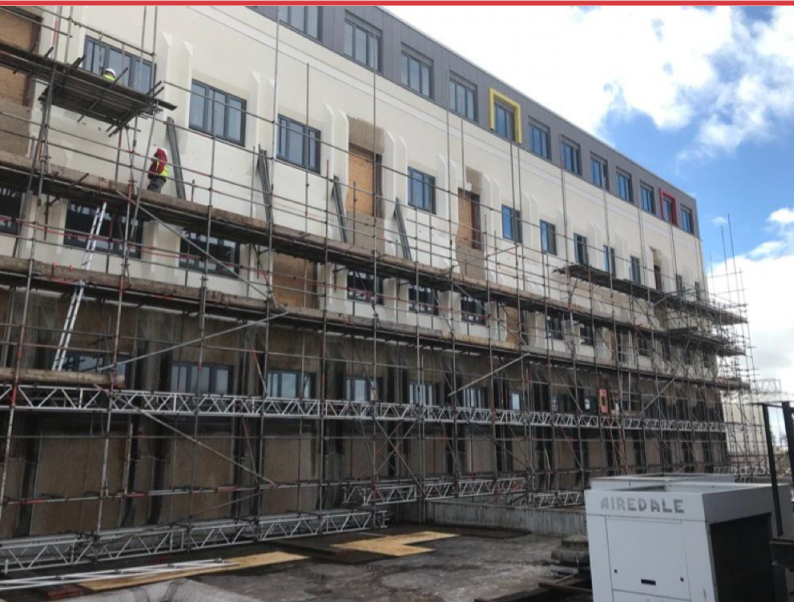
## REAR ELEVATION

The Scaffolding on the Rear Elevation was subject of modifications at the time of the scaffolding inspection and was not to be used by Contractors until all of the modifications had been completed by the Scaffolding Contractor.

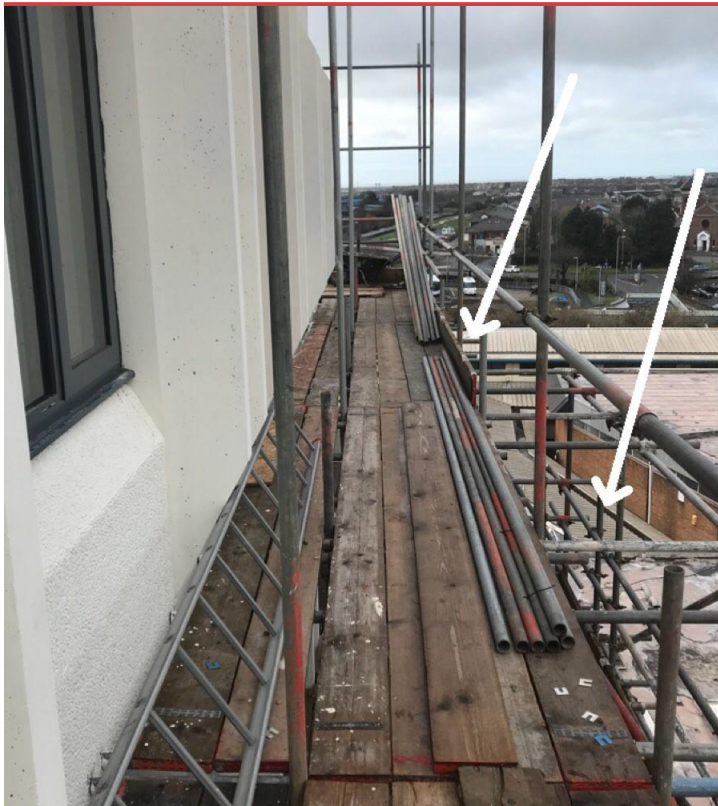
## REAR ELEVATION

The scaffolding on the Rear Elevation is not to be used until all scaffold materials have been removed and all modifications and alterations have been completed.

There are scaffold materials that need to be removed and Handrails put in place in order to create Double Handrails to prevent falls from height and meet the requirements of TG20:13.

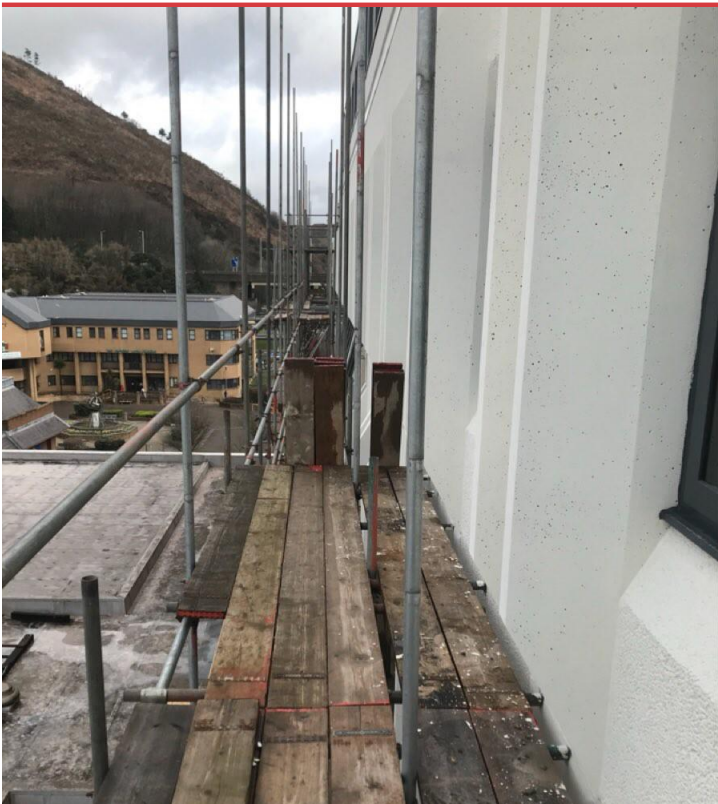
## REAR ELEVATION

The scaffold materials need to be removed from the Working Lifts prior to Contractors using the Rear Elevation.

All modifications and alterations need to be carried out prior to next use of the scaffolding.

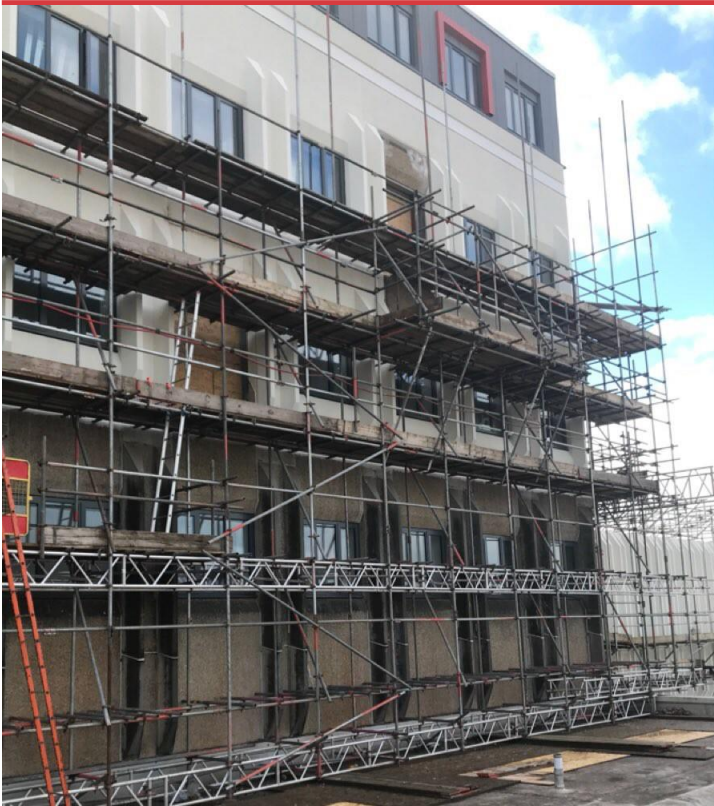
## REAR ELEVATION

The Top Working Lifts have been dismantled as part of the progressive dismantle. There are now only 2 rows of Ties on the Rear Elevation

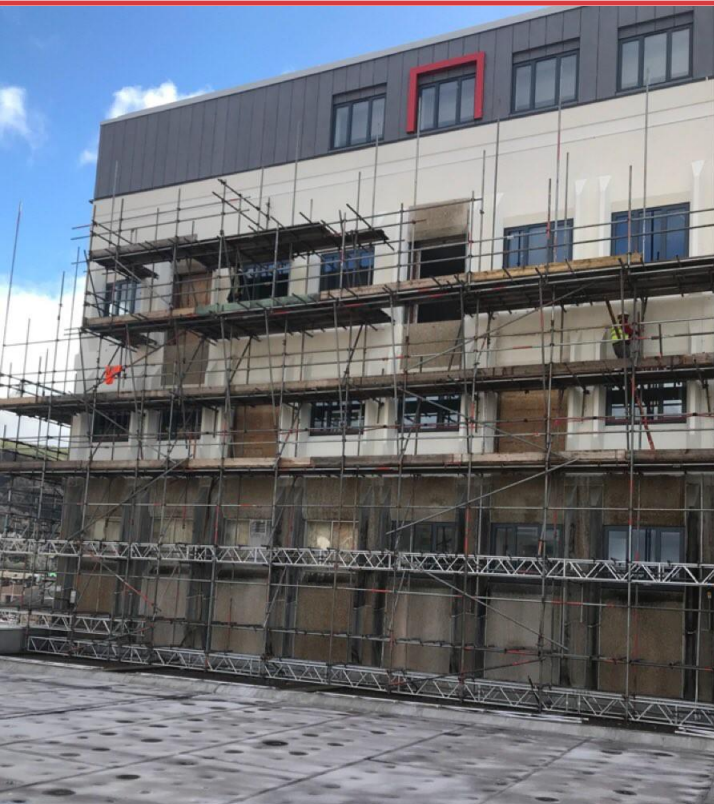
## REAR ELEVATION

Extra Working Lifts are being erected on the outside of the scaffold on the Rear Elevation

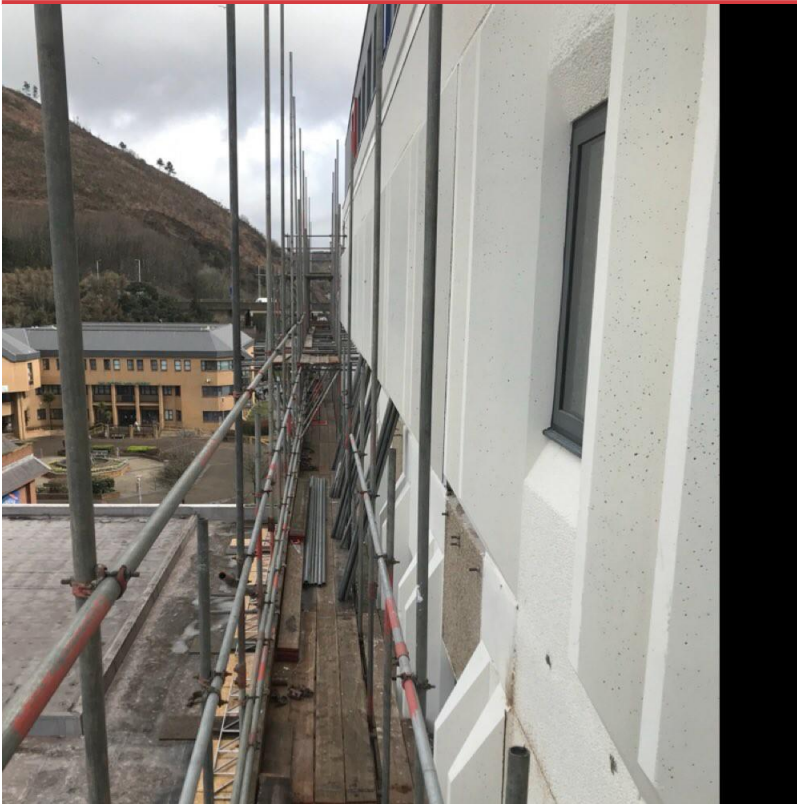
### **REAR ELEVATION**

Scaffold materials need to be removed from the Working Lifts prior to the next use by the Working Parties

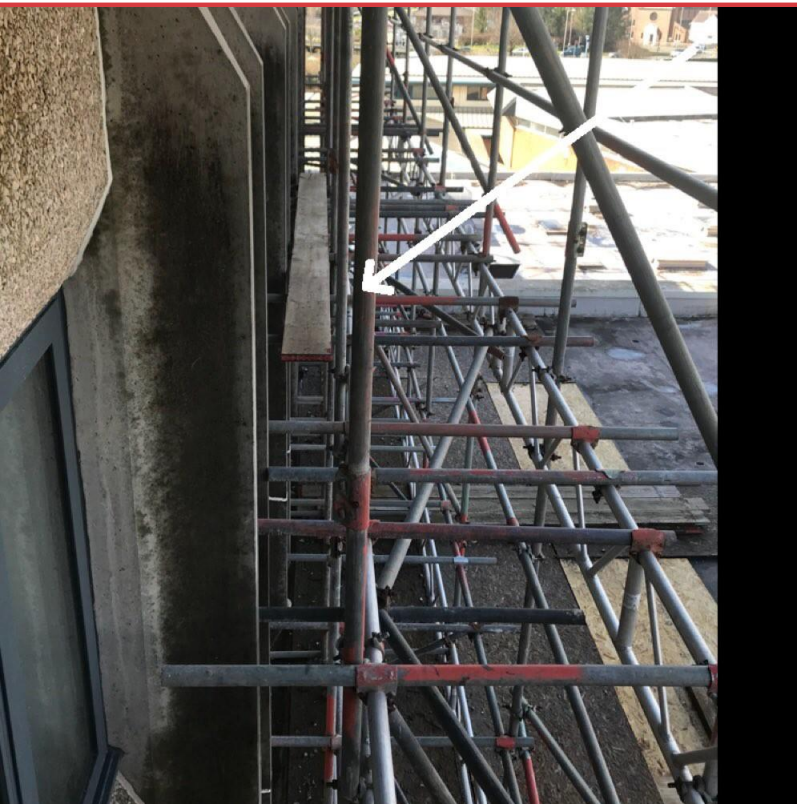
### **REAR ELEVATION**

A scaffold board has been left on a non Working Lift that needs to be removed in order to prevent it blowing

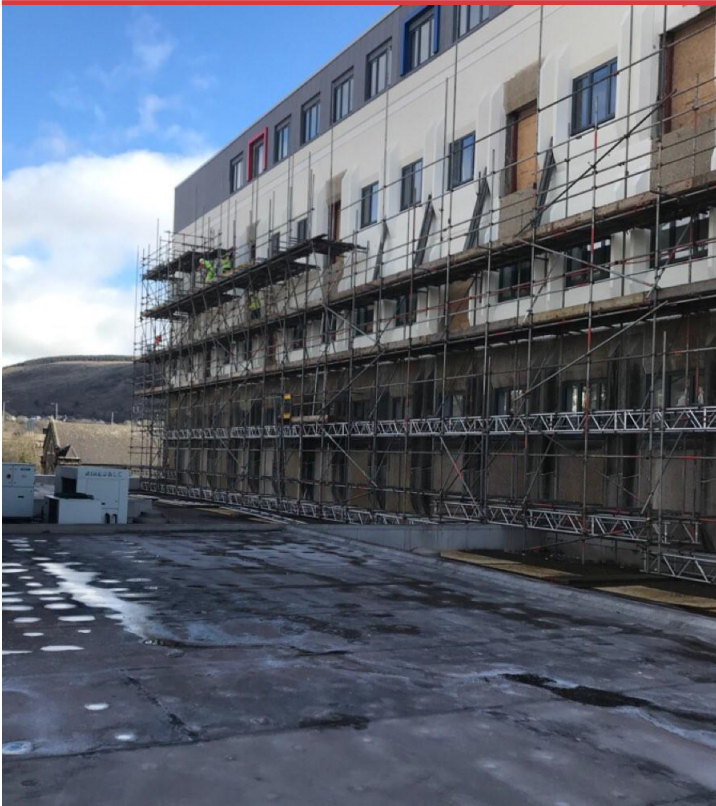
## REAR ELEVATION

The Working Lifts were clear of debris and waste materials

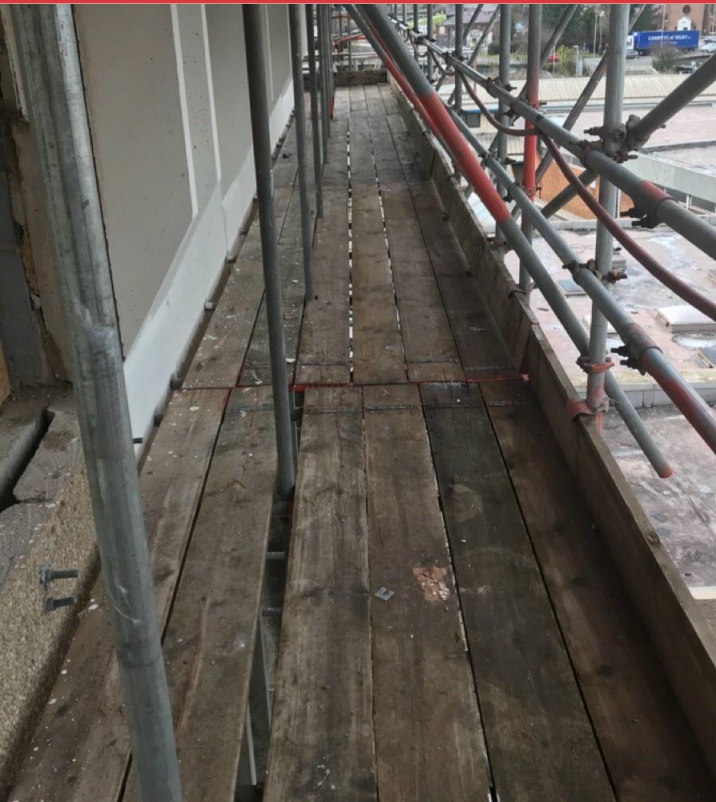
## REAR ELEVATION

The Working Lifts were clear of debris and waste materials

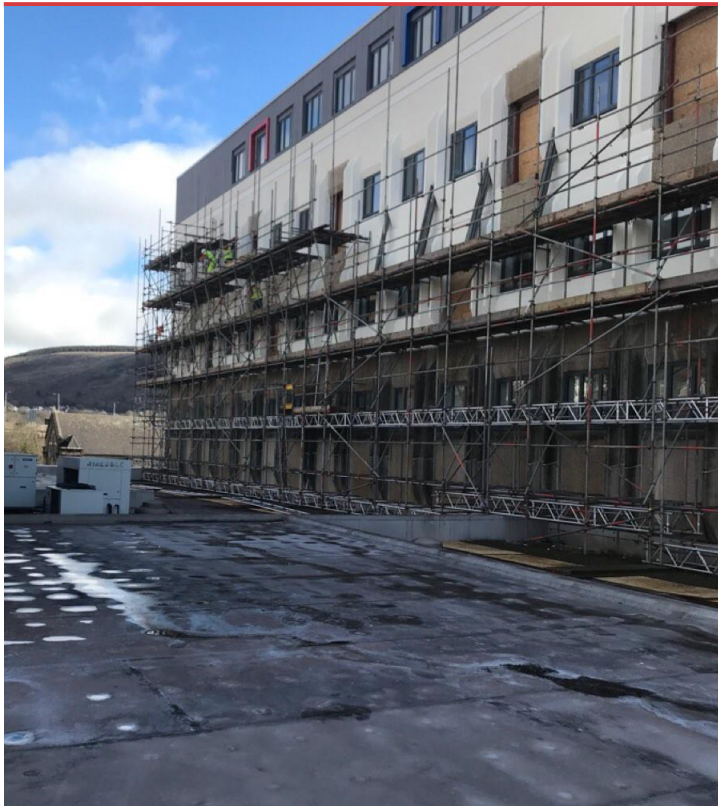
## REAR ELEVATION

There are sufficient ties in the scaffold on the Rear Elevation in order to meet the requirements of the Design and of TG20:13

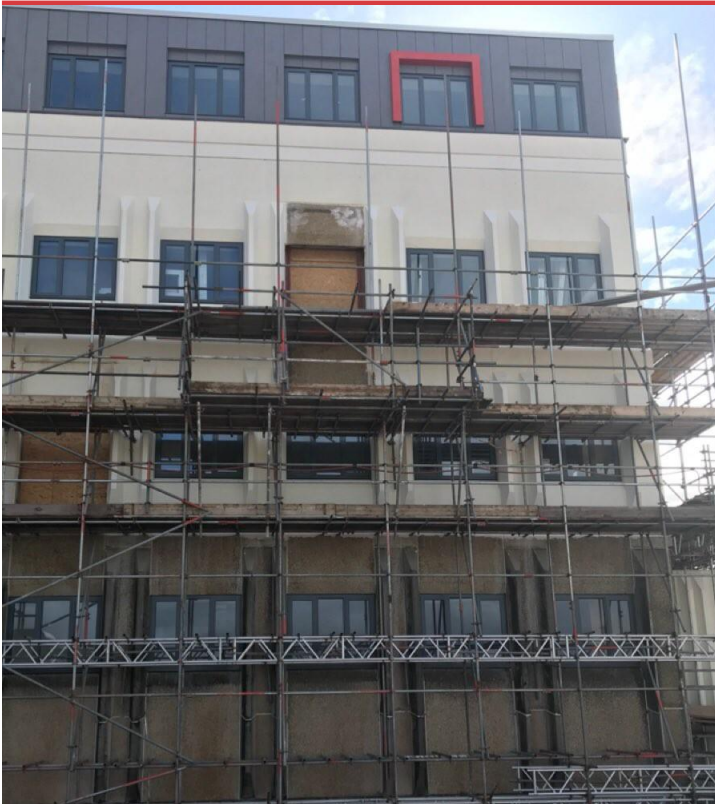
## REAR ELEVATION

The scaffolds being erected outside of the Tied scaffold were for the use of Contractors when fitting the Pods.
